RAILROAD ACCIDENT INVESTIGATION

Report No. 3956

NEW YORK CENTRAL RAILROAD COMPANY

JUNE 16, 1962

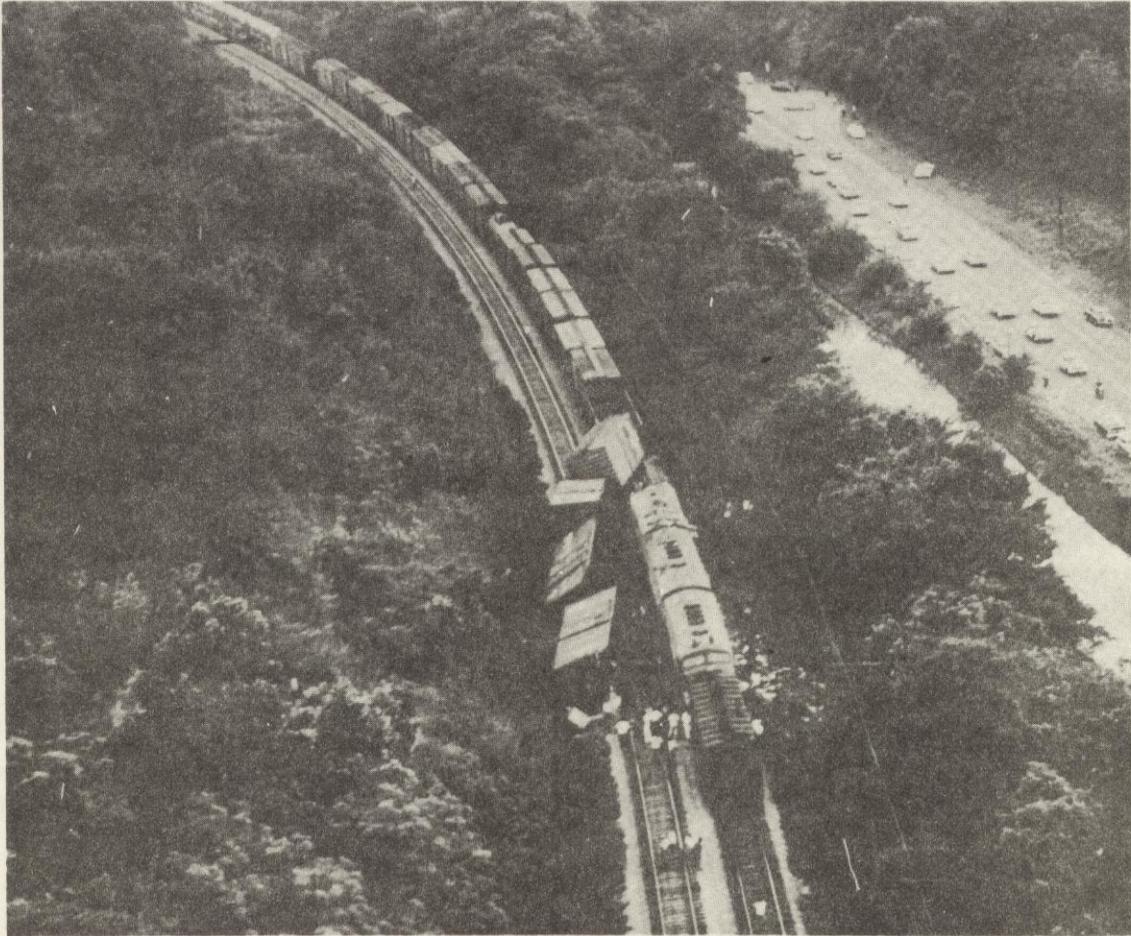
Photo shows the 3 diesel-electric units and the caboose of Extra 5008 West on westward main track in right foreground. Rear 4 cars of Extra 1717 West shown in various positions along eastward main track. Destroyed caboose of latter train is not visible.

The caboose of Extra 1717 West and the 133rd to the 136th car, inclusive, were derailed and stopped in various positions on the structure of both main tracks as shown in a photograph at the front of this report. Of this derailed equipment, the caboose and 3 cars were destroyed, and 1 car was slightly damaged.

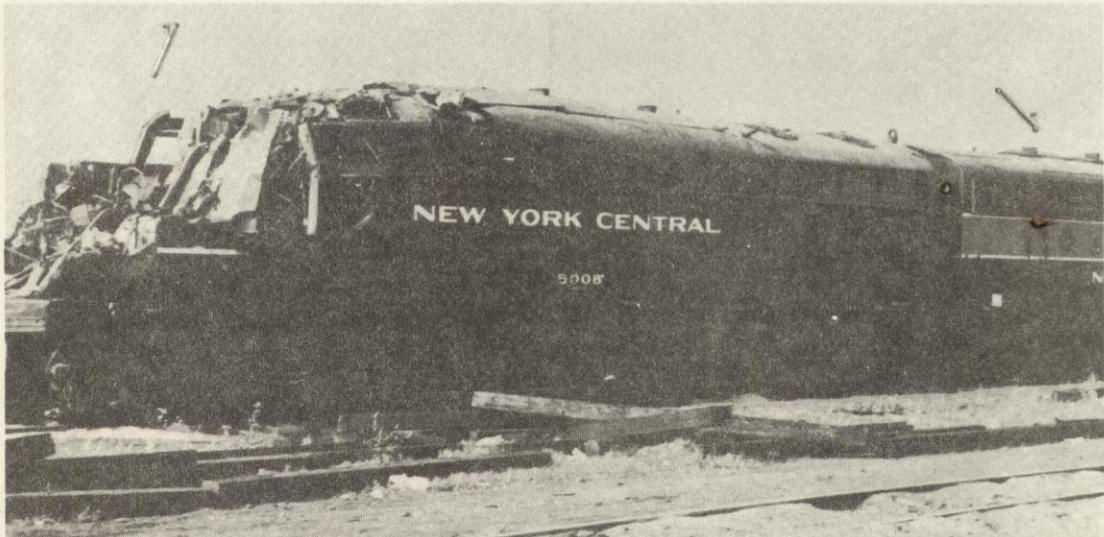
First diesel-electric unit of Extra 5008 West.

The 1st diesel-electric unit of Extra 5008 West was derailed. It stopped upright on and in line with the structure of the westward main track, and with the front end 174 feet west of the point of accident. It was heavily damaged.

Examination of the control compartment of the first diesel-electric unit of Extra 5008 West disclosed that because of damage resulting from the collision the position of the controls at the time of the accident could not be determined. The pressure-regulating device was found to be adjusted to maintain brake-pipe pressure at 72 pounds instead of 110 pounds as required by the carrier's air brake rules when a locomotive is being operated with a caboose only. The position of the rotair valve on this locomotive unit could not be determined because of its damaged condition. However, the rotair valves on the trailing units were found in freight lap position instead of in passenger lap position, as required under the circumstances in which the locomotive was being operated at the time of the accident.
