RAILROAD ACCIDENT REPORT.

NEW YORK CENTRAL RAILROAD COMPANY
TRAIN 1/NY-4 EXTRA 2020 EAST AND TRAIN ND-5 EXTRA 5305 WEST
HEAD-ON COLLISION
NEW YORK CITY, NEW YORK
May 22, 1967,

U. S. NATIONAL TRANSPORTATION SAFETY BOARD ,

NEW YORK CENTRAL RAILROAD COMPANY
TRAIN 1/NY-4 EXTRA 2020 EAST and TRAIN ND-5 EXTRA 5305 WEST
HEAD-ON COLLISION
NEW YORK CITY, NEW YORK
May 22, 1967

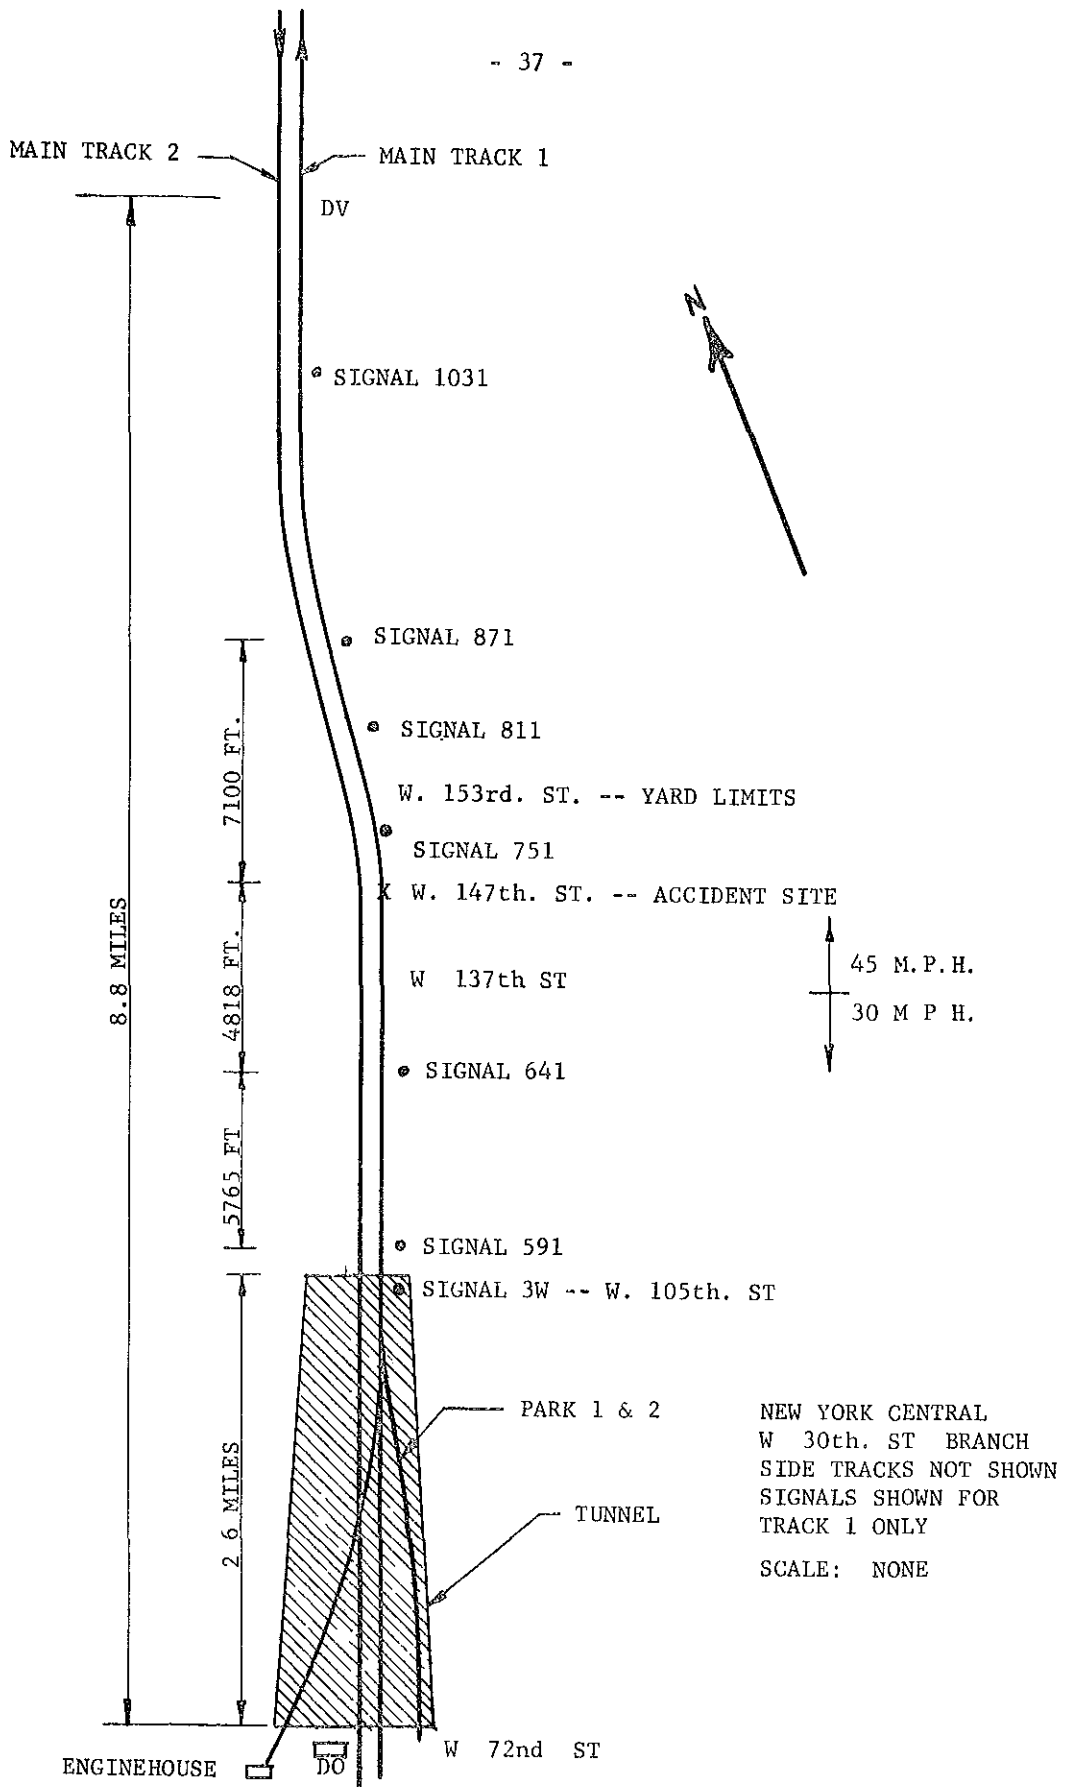
NEW YORK CENTRAL
 W 30th. ST BRANCH
 SIDE TRACKS NOT SHOWN
 SIGNALS SHOWN FOR
 TRACK 1 ONLY
 SCALE: NONE
