New Niagara Gorge Arch Nearing Completion

The Two Cantilever Arms of the Michigan Central's 640-Ft. Span Were Joined in October

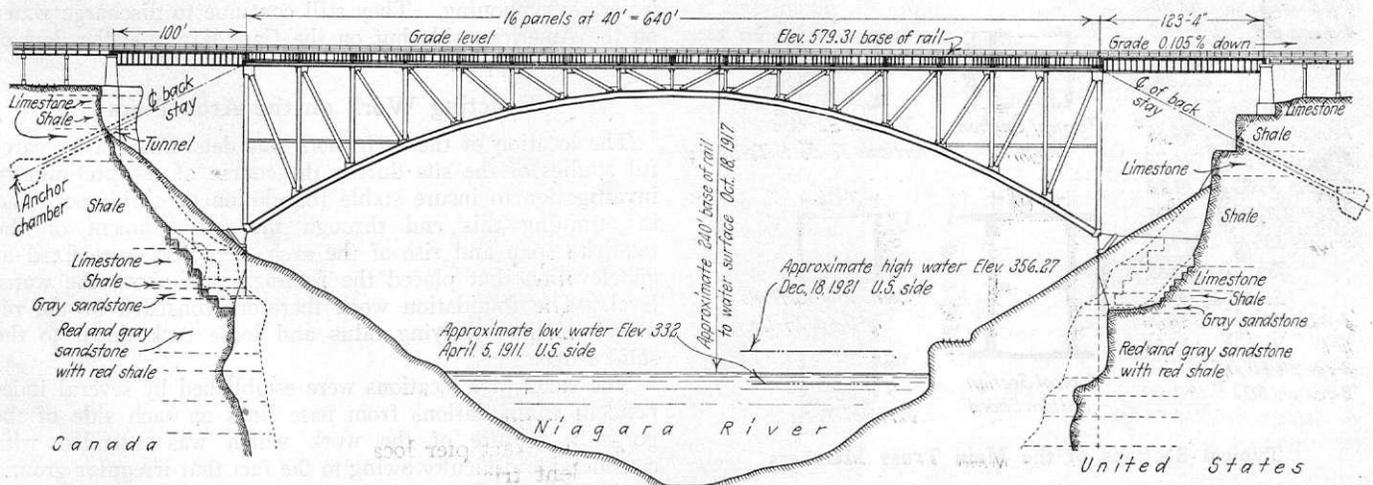
The New Arch in Relation to the Gorge

The new bridge is located in the space between the old cantilever structure and the 550-ft. arch used by the Canadian National (Grand Trunk). It has a span of 640 ft. from center to center of hinge pins and a rise of 105 ft. It is designed to carry two railway tracks on the deck at 13 ft. centers. It belongs to the spandrel braced type of steel arch with the lower chord conforming to a parabolic curve and the top chord horizontal. It was designed for erection by the cantilever method with a pin bearing between the two halves of the lower chord at the crown so that it is a three-hinge structure for dead load exclusive of the weight of the ballast and the track construction. However, as the crown joint in the top chord will be riveted solid, the structure will function as a two-hinged arch for live load.

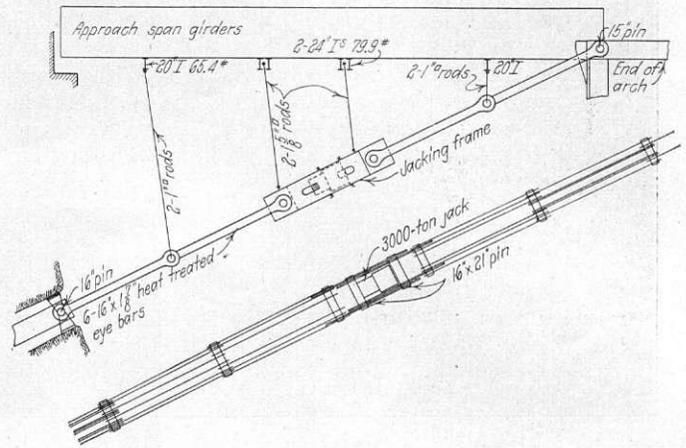
Diagram of the Back Stay Structure

The next step was the erection of the backstay system complete, including the suspender rods by means of which

The closing gap between the ends of the completed half arches was accomplished by means of four hydraulic jacks, one for each backstay. The capacity of each of these jacks was 3,000 tons and they had been tested in the storage yard at the bridge site to 2,500 tons, which was about 25 per cent more than the required load. A jack was located at the center of each backstay between two pairs of sliding

plates, of which one pair was in fixed connection with the anchorage, by way of the lower half of the backstay, and the other pair of plates was connected to the end of the top chord by way of the upper half of the backstay. Two pins, specially designed to bear on the plunger end and the base of the jack, transferred the stress from the jack to the plates. The upper of these pins was fixed to the plates attached to the anchorage and was sliding in slotted holes in the plates attached to the end of the top chord. The sliding condition for the lower jacking pin was the reverse.

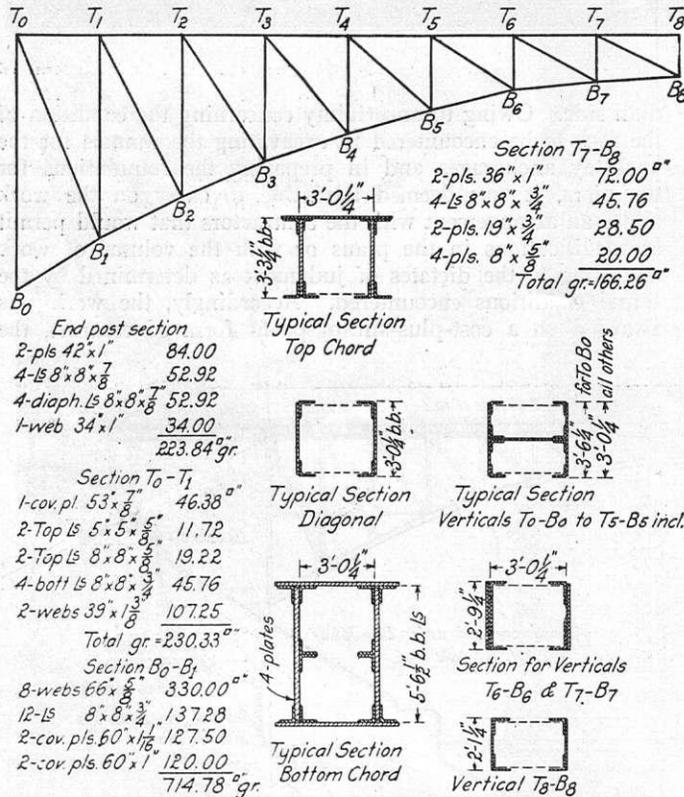
Typical Sections of the Main Truss Members

The size and general characteristics of the main truss members are given in one of the accompanying drawings. The bottom chords are of closed box section with two webs, 3 ft. 2 $\frac{3}{4}$ in. center to center by 5 ft. 6 $\frac{1}{2}$ in. deep, each web consisting of four plates $\frac{5}{8}$ in. thick. The angles are 8 in. by 8 in. by $\frac{3}{4}$ in. throughout, the variation in the makeup being made by changing the thickness of cover plates. The maximum bottom chord section has a gross area of 714.78 sq. in., to provide for a maximum resultant stress of 9,700,000 lb. The joints in the bottom chord members are necessarily made at the panel points and the abutting ends are milled for bearing on only the middle 2 ft. 6 in. of the total depth of 5 ft. 6 $\frac{1}{2}$ in. These chord splices have been proportioned for 100 per cent riveting. The two trusses are set on a batter of 8 vertical to 1 horizontal, all members of the trusses, including the top chord, conforming to this batter.

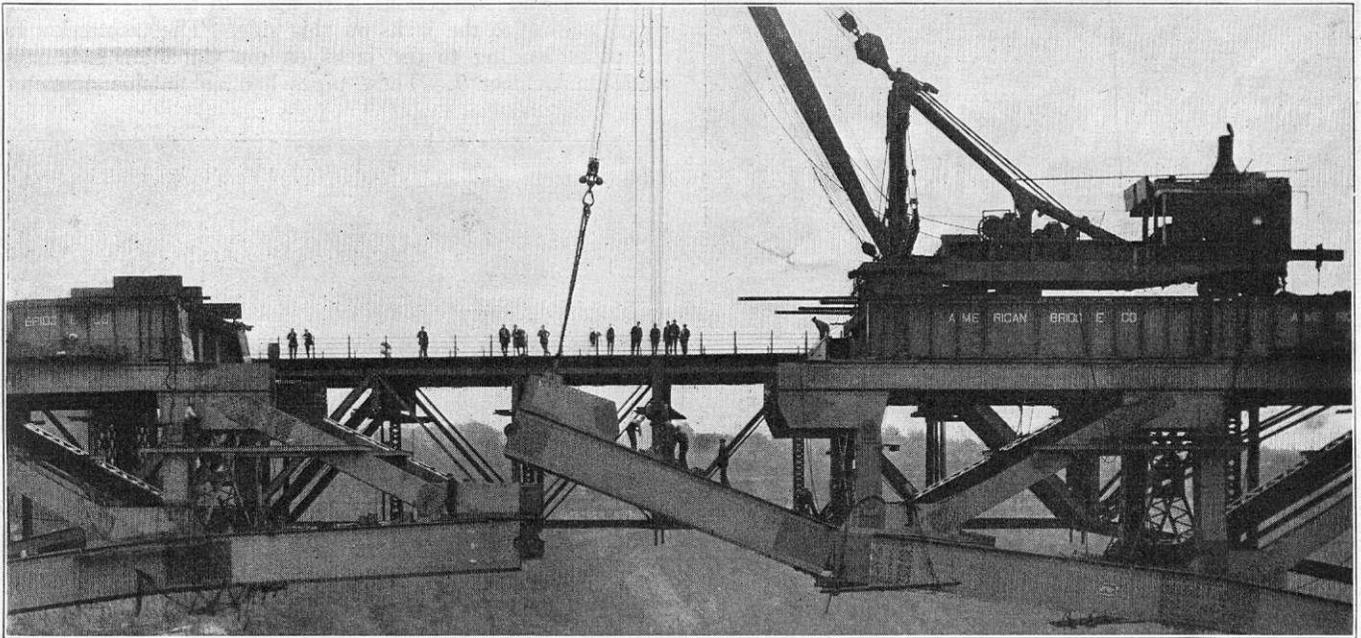
Placing the Closing Member in Bottom Chord of the North Truss

lined up with little effort. As soon as this was done the placing of the splice plates at the center joint of the bottom chord was started. These plates were very difficult to enter and the work had not been finished by 6 p. m.

The placing of the splice plates at the center joint and bolting them to the Canadian half of the arch was resumed on the following morning.

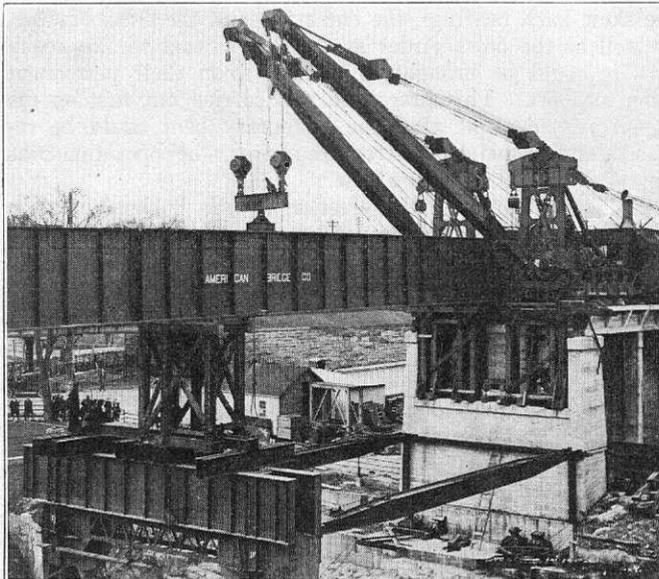
The Erection of the Approach Span Girders Was a Difficult Task

The problem was solved by placing the approach girders first, providing a temporary outer support for them in the form of a temporary bent consisting of the posts for the second panel point (Canadian side) of the arch together with the cross bracing and a temporary base section for the columns. This bent was erected 84 ft. out from the approach pier on the American side and secured in place by struts and guys, after which the approach girders were set in place. This operation required the employment of two derrick cars and a carefully developed plan of procedure owing to the length and weight of the girders to be handled. The 125-ft. girders on the American side weighed 84 tons each.

With the girders in place the erecting equipment moved out on the span as far as the temporary bent and erected the skew back bearings, the end posts and the cross bracing, as well as the cross girder at the top, so that the approach girders could be brought to bearing upon their permanent outer support. This procedure was carried out first on the American side and after the temporary bent could be released and transferred across the river, the operation was repeated on the Canadian side.

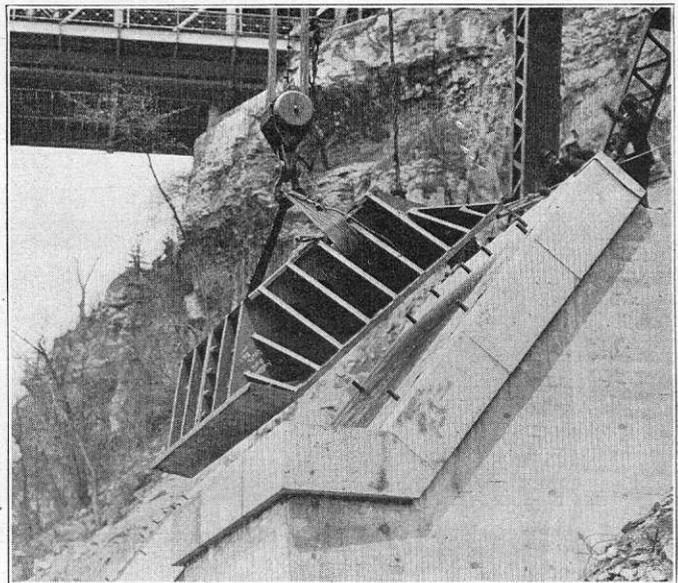
Setting the Lower Bearing Casting on One of the Arch Pier Skewbacks

By far the most exactng feature of the pier construction was the finishing of the concrete skew backs to receive the granite coping, the setting of the coping stones and the

dressing of these stones to the required degree of accuracy with respect to location and surface. The specifications permitted a tolerance in the granite surfaces of only 1/16 in., as the correction of irregularities of contact between the skew back castings and the masonry was limited to the adjustment that could be obtained with a joint of 1/16 in. sheet lead. In carrying out this work the stones were set 3/4 in. high and then dressed down by stone cutters, the final cut requiring a "10 cut" finish to come within the tolerance limit. This work entailed the services of a force of stone cutters for a number of weeks.

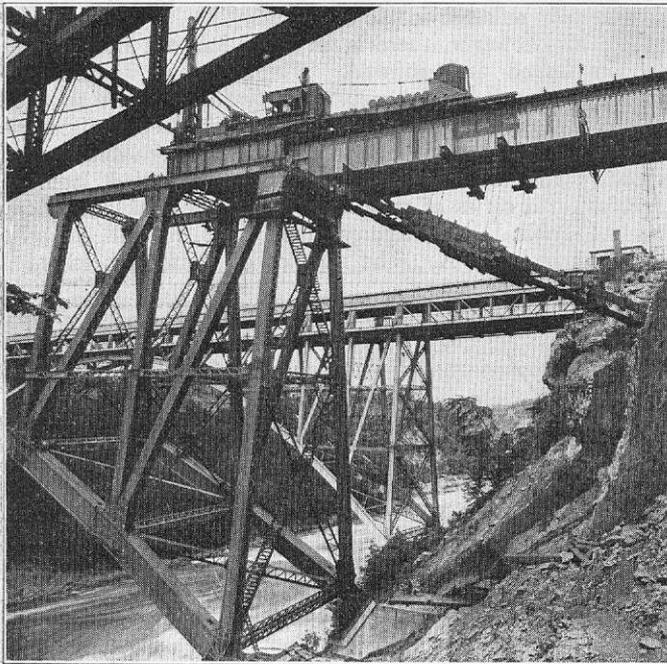
An Early Stage in the Erection of the Arch on the United States Side

arm. As the structure was double-tracked, the cars alternated from one track to the other in placing the members in the two trusses, the members being brought forward on trucks on the other track. The normal procedure was as follows: After completing the erection of the floor for one panel, the derrick car, from its position on one of the tracks, erected the bottom chord section for the next panel on that side. Owing to the fact that the bottom chord splices are 100 per cent riveted the bottom chord members could be safely supported as a cantilever from the joint just as soon as the joint had been fully bolted and pinned and thus release the fall line for the erection of the diagonal which was placed next. Following this, the derrick car was transferred to the second track to place the bottom chord and diagonal on that side; the bottom laterals and strut and the post and top chord on that side. The derrick car was then moved to the first track for the erection of the post and top chord on that side, the cross frame and top laterals. The floor system for the panel was then erected from the same position of the derrick floor.

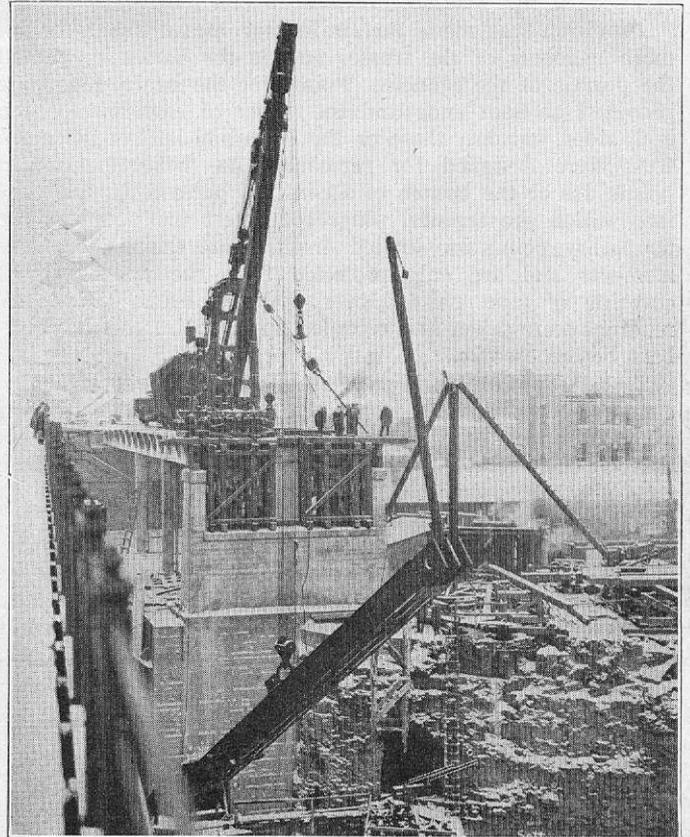
Installing a Part of the Back Stay in the South Tunnel on the Canadian Side. The North Tunnel Is Seen at the Right

would be imbedded in solid rock. The tunneling operations involved the driving of four shafts 7 ft. wide by 6 ft. 6 in. high at a downward pitch of 26 1/2 deg. from the horizontal for a distance of 82 ft. on the Canadian side and 105 ft. on the American side and terminating in anchorage chambers approximately 20 ft. deep, 20 ft. high and 17 ft. wide.

anchor girders and the tunnel sections of the backstays were installed, after which operation had to be suspended pending the back filling of the tunnels and anchor chambers with concrete.
